# Ad-hoc fire test on a pilot-scale concrete floor slab incorporating cast-in PVC conduits, spanning a fire separating wall

## Test Report

**Author:** Chris Wojcik  
**Report number:** FSP 2036  
**Date:** 19 August 2019

**Client:** NOS Automation Solutions Pty Ltd

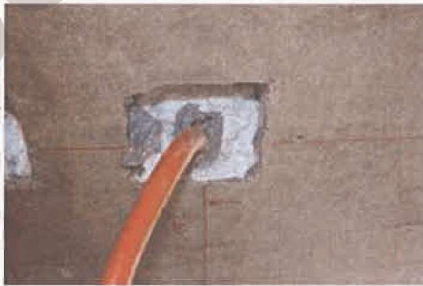
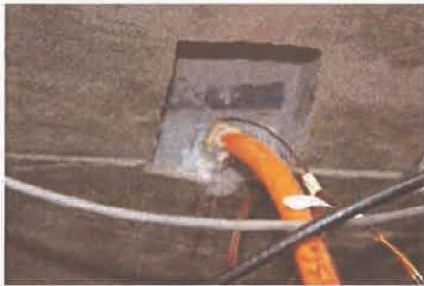
SPECIMEN 1		
32-mm OD PVC conduit carrying a single electrical cable sealed on the unexposed end		
CAST-IN SERVICE		
Description	Size and location within the concrete floor	End conditions
32-mm PVC conduit	1300-mm long x 32-mm OD PVC conduit located within the concrete floor with 50-mm concrete cover	Conduit sealed on the unexposed block-out end only using Hilti CP606 Firestop Acrylic Sealant to a depth of 20-mm and finished with a 20-mm fillet
Electrical cable	Single 15-mm diameter 16-mm <sup>2</sup> 2 core plus Earth copper/XLPE/PVC electrical cable	Protruded at least 500-mm from each block out end
Photographs	Fire exposed block out end	Unexposed block out end

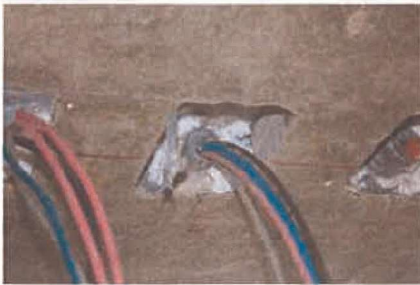
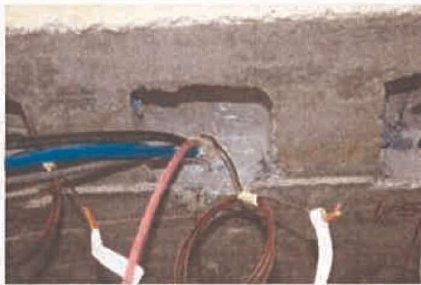
SPECIMEN 3		
25-mm OD PVC conduit carrying various data and communication cables sealed on the unexposed end		
CAST-IN SERVICE		
Description	Size and location within the concrete floor	End conditions
25-mm PVC Conduit	1300-mm long x 25-mm OD PVC conduit located within the concrete floor with 50-mm concrete cover	Conduit sealed on the unexposed block-out end only using Hilti CP606 Firestop Acrylic Sealant to a depth of 20-mm and finished with a 20-mm fillet
Data and communication cables	<p>One (1) off 7-mm dia. Electra cables Coaxial cable RG6Q (blue)</p> <p>One (1) off 5-mm dia. Clipsal C-Bus Category 5 5005C305BST (pink) data cable</p> <p>One (1) off 5-mm dia. EAS 7206 - 6 core data cable (grey)</p> <p>Two (2) off 5-mm dia. Electra cables CAT6 (blue) data cable</p>	Protruded at least 500-mm from each block-out end
Photographs	Fire exposed block-out end	Unexposed block-out end

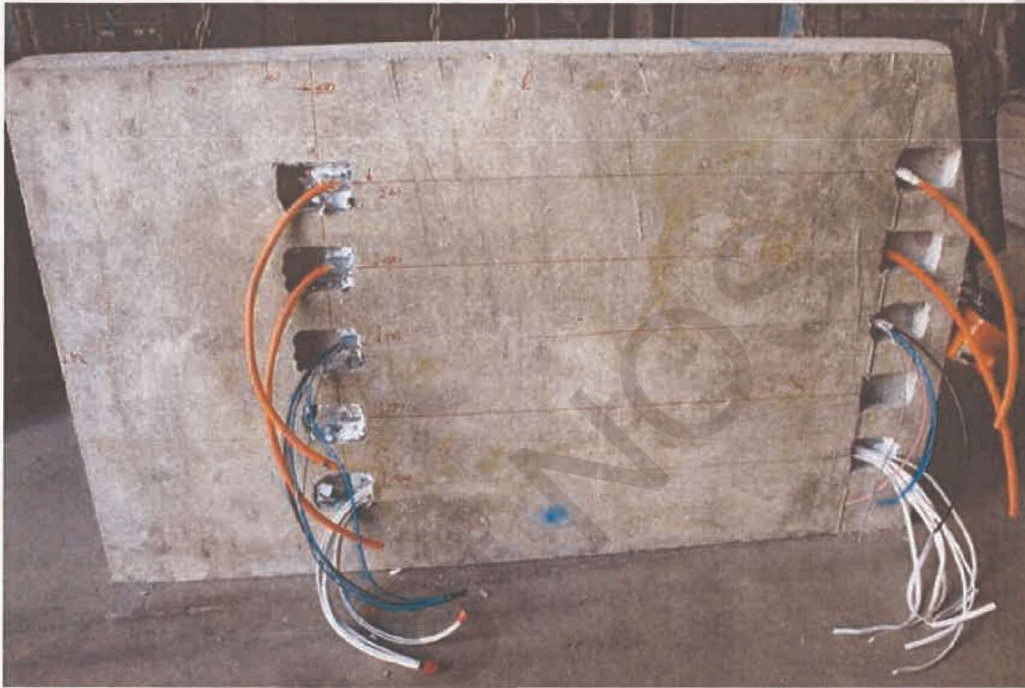
PHOTOGRAPH 1 – UNDERSIDE OF THE CONCRETE FLOOR SLAB PRIOR TO TESTING

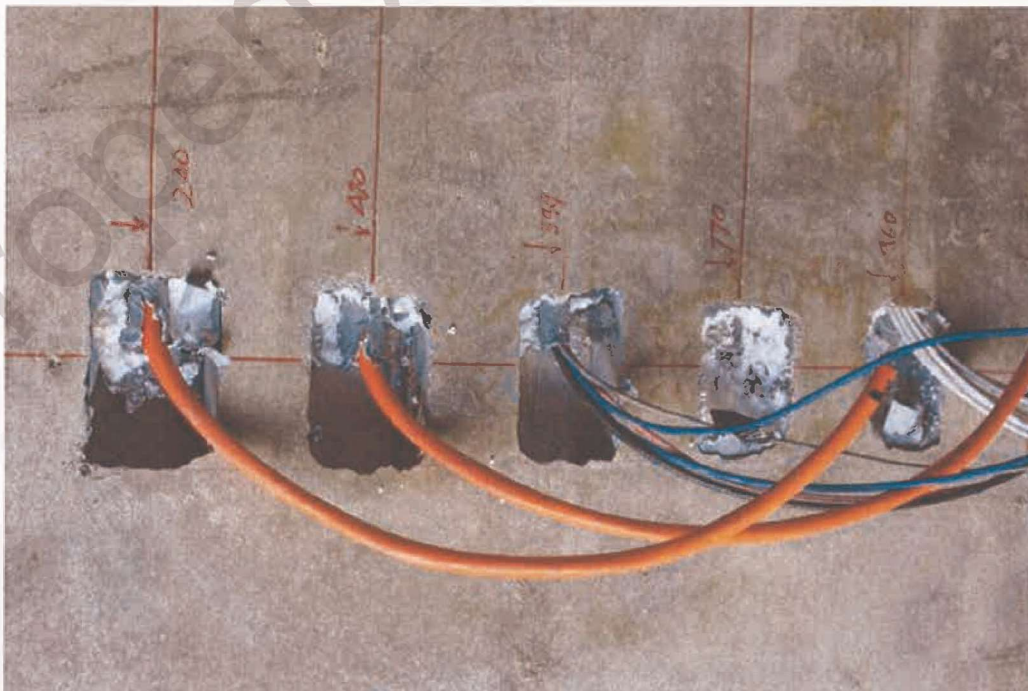
PHOTOGRAPH 2 – CONDUIT BLOCK-OUTS ON FIRE EXPOSED SIDE PRIOR TO TESTING

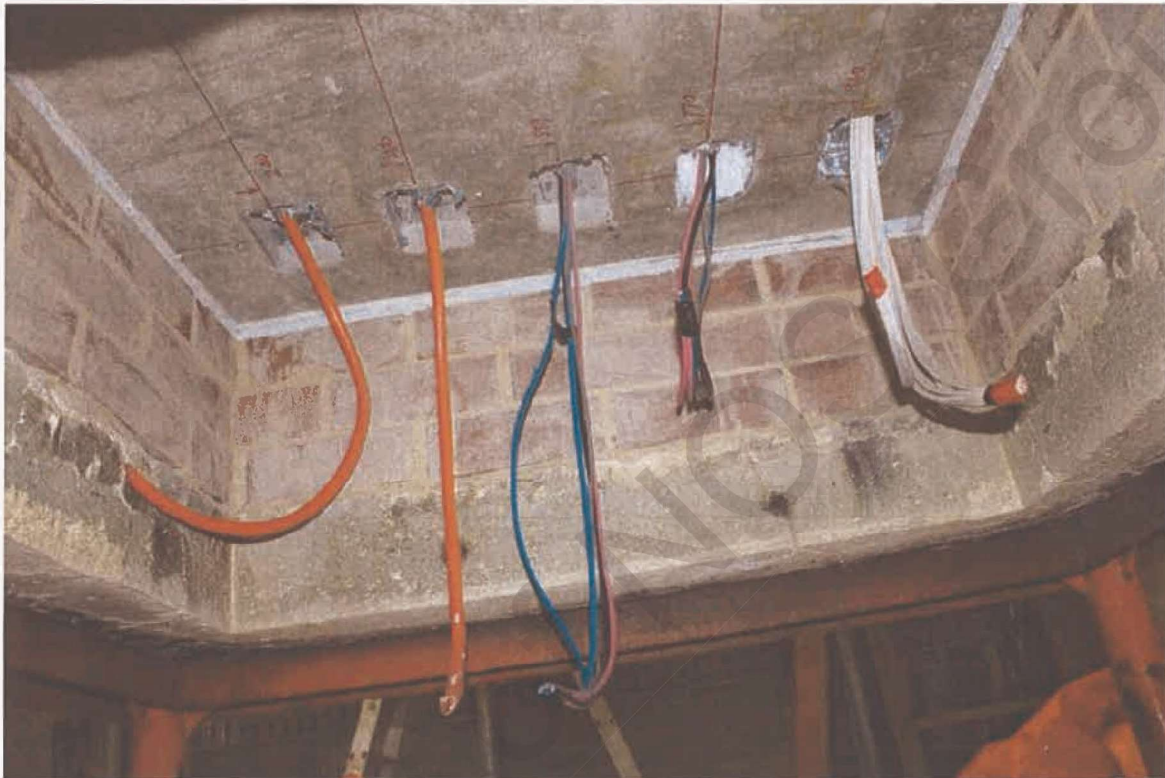
PHOTOGRAPH 3 – EXPOSED SIDE OF SPECIMENS PRIOR TO TESTING

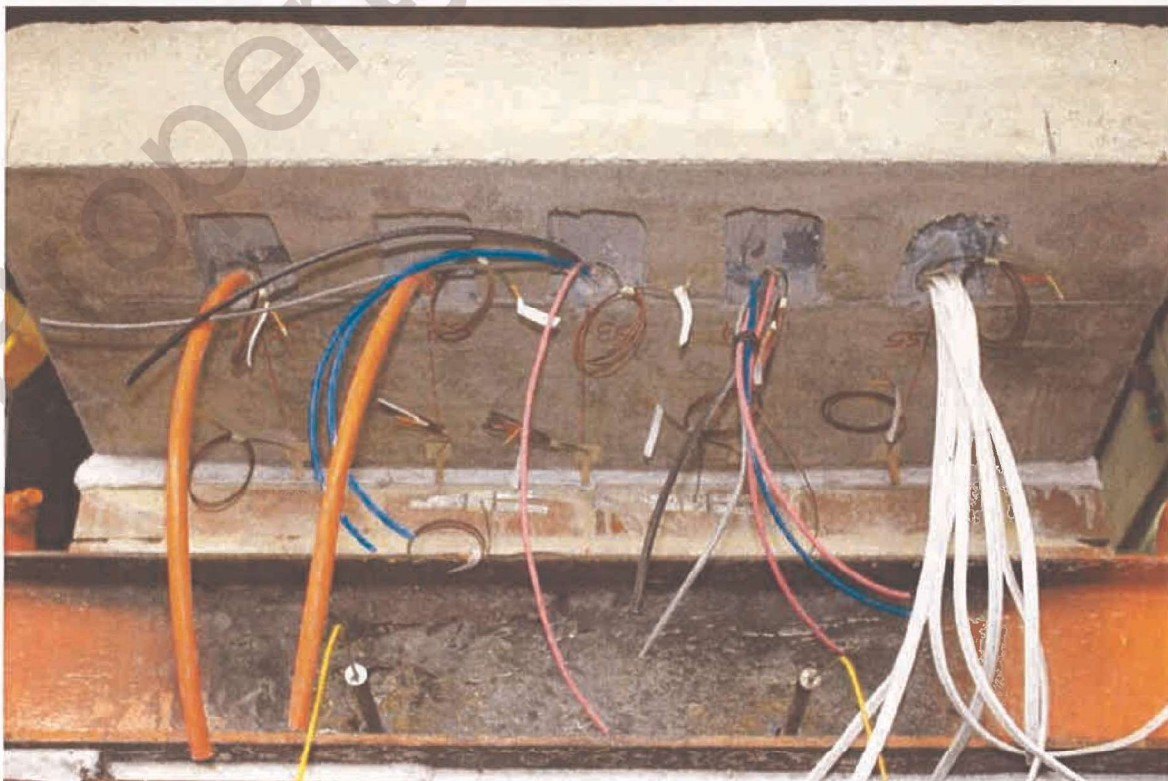
PHOTOGRAPH 4 – UNEXPOSED FACE OF SPECIMENS PRIOR TO TESTING

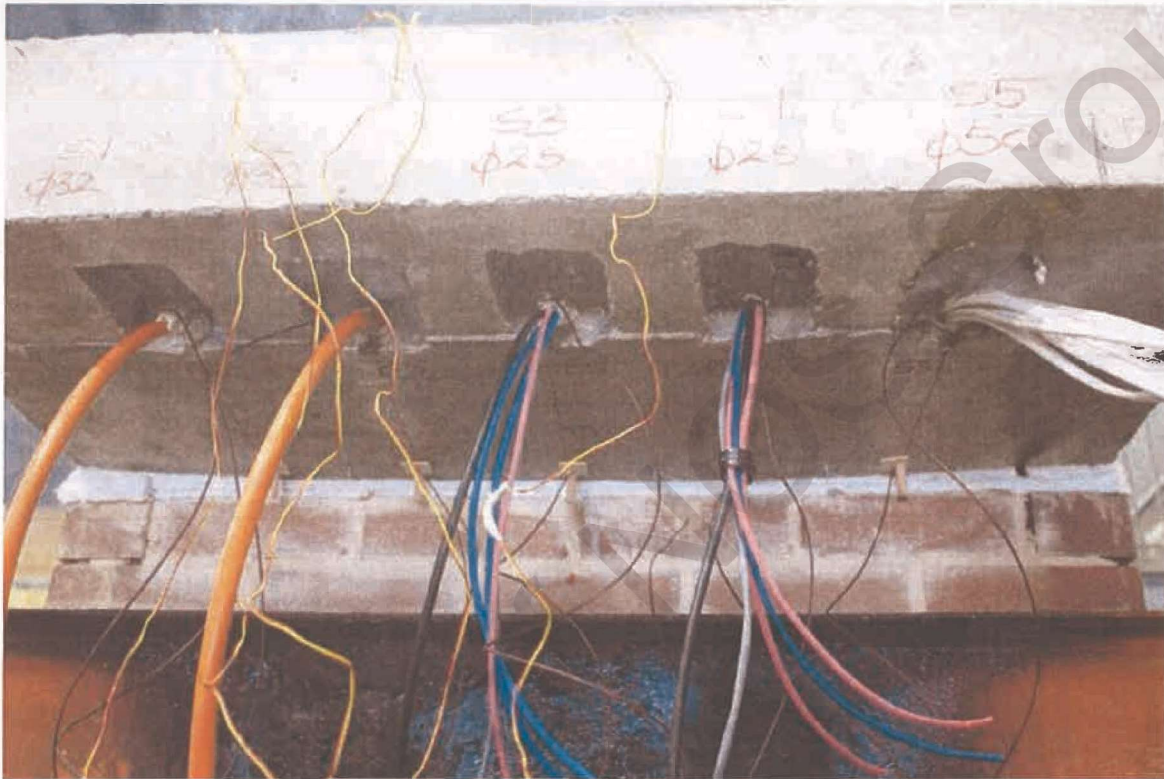
PHOTOGRAPH 5 – SPECIMENS AT 30 MINUTES INTO THE TEST

- 1 minute - Smoke is being emitted from the block-outs of Specimens 2, 4 and 5.
- 3 minutes - The amount of smoke being emitted from the block-outs of Specimens 2, 4 and 5 is increasing.
- 15 minutes - A single spalling sound has been emitted from inside the furnace.
- 20 minutes - Condensation is dripping from inside the block-outs of Specimens 2 and 5.
- 45 minutes - The amount of smoke emitted from the block-out of Specimen 5 has decreased.
- 60 minutes - Smoke is no longer being emitted from any of the specimens.
- 80 minutes - Light smoke and moisture is being emitted from the block-outs of Specimens 2 and 5.
- 120 minutes - Condensation continues to drip from the block-outs of Specimens 2 and 5. Light smoke is emitted from the block-out of Specimen 5.
- 121 minutes - Test terminated.

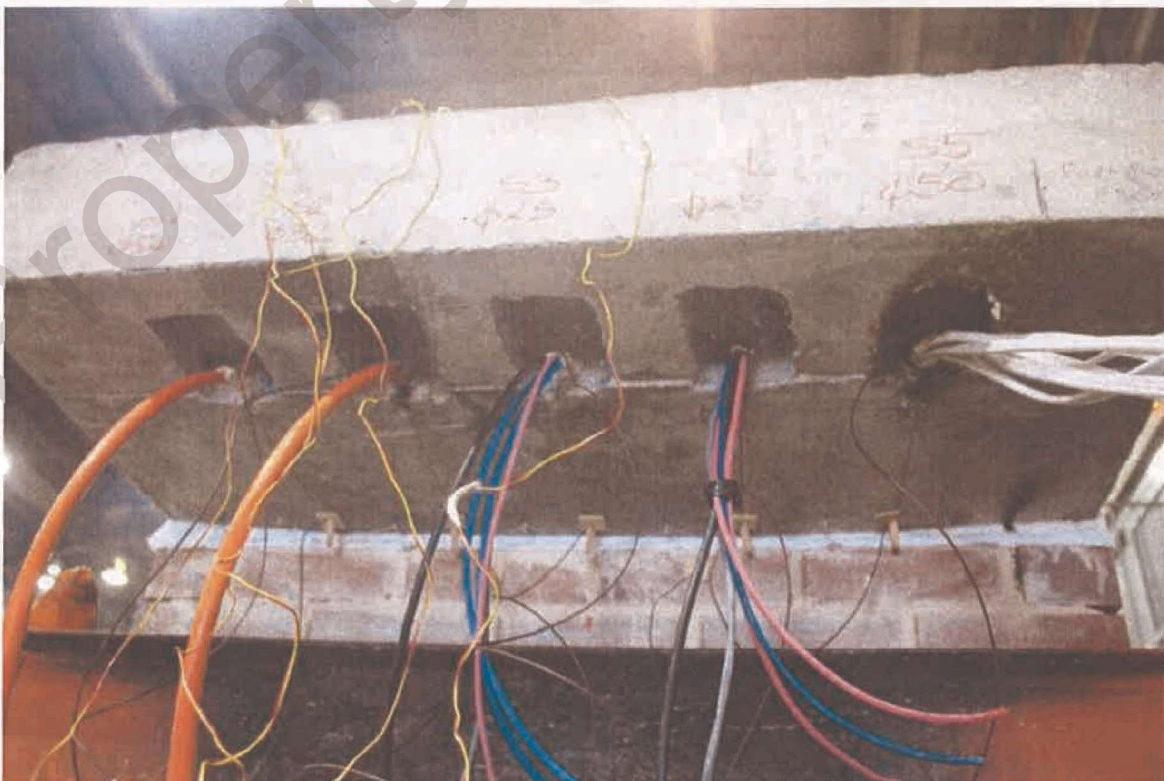
PHOTOGRAPH 6 – SPECIMENS AT 60 MINUTES INTO THE TEST

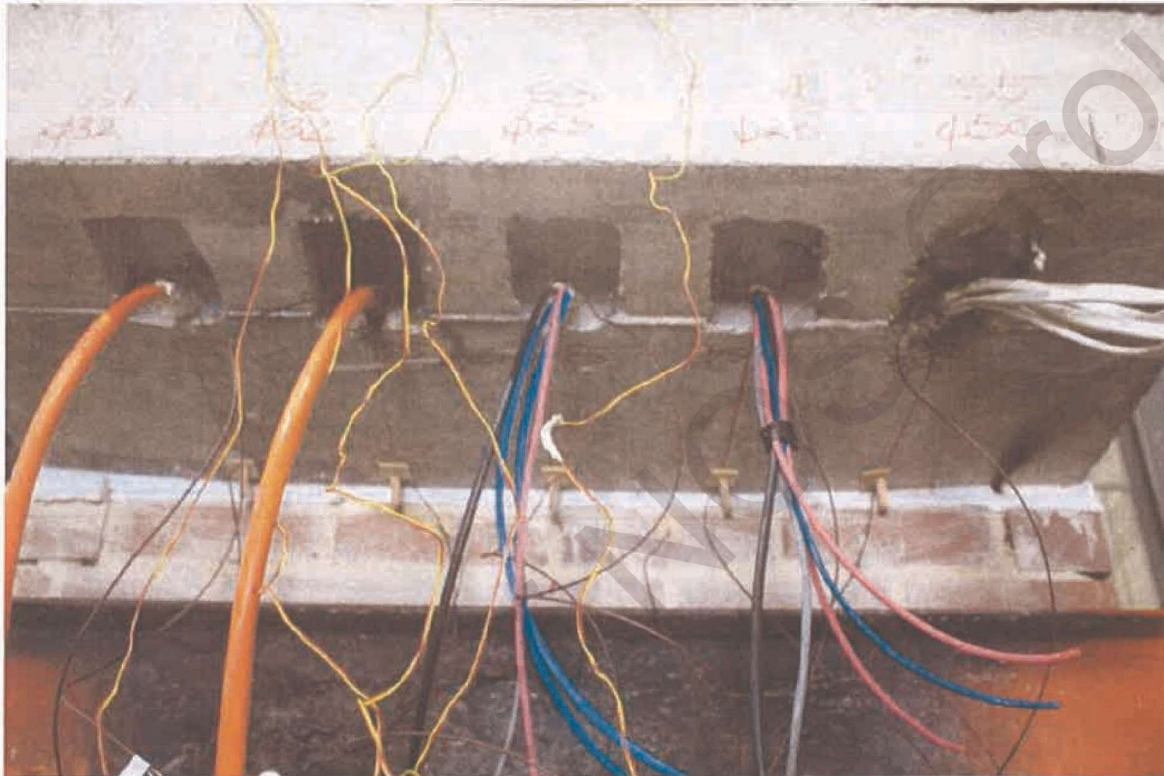
PHOTOGRAPH 7 – SPECIMENS AT 90 MINUTES INTO THE TEST

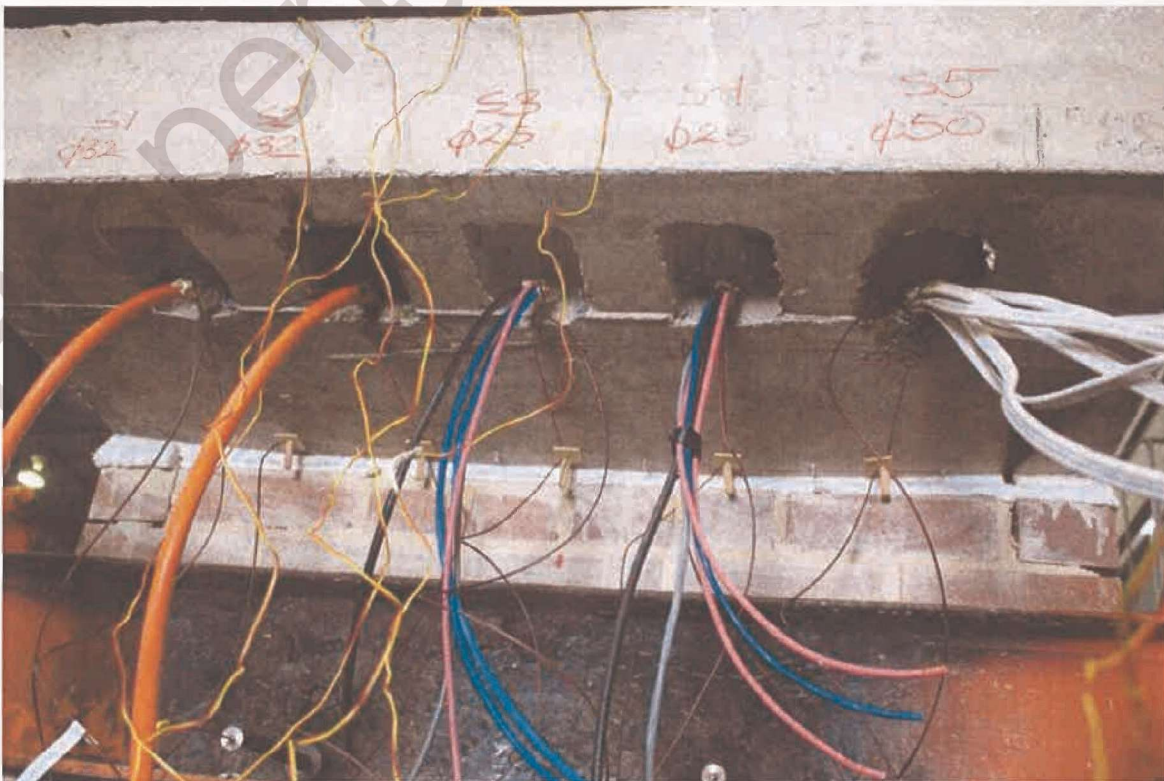
PHOTOGRAPH 8 – SPECIMEN AT THE CONCLUSION OF TESTING

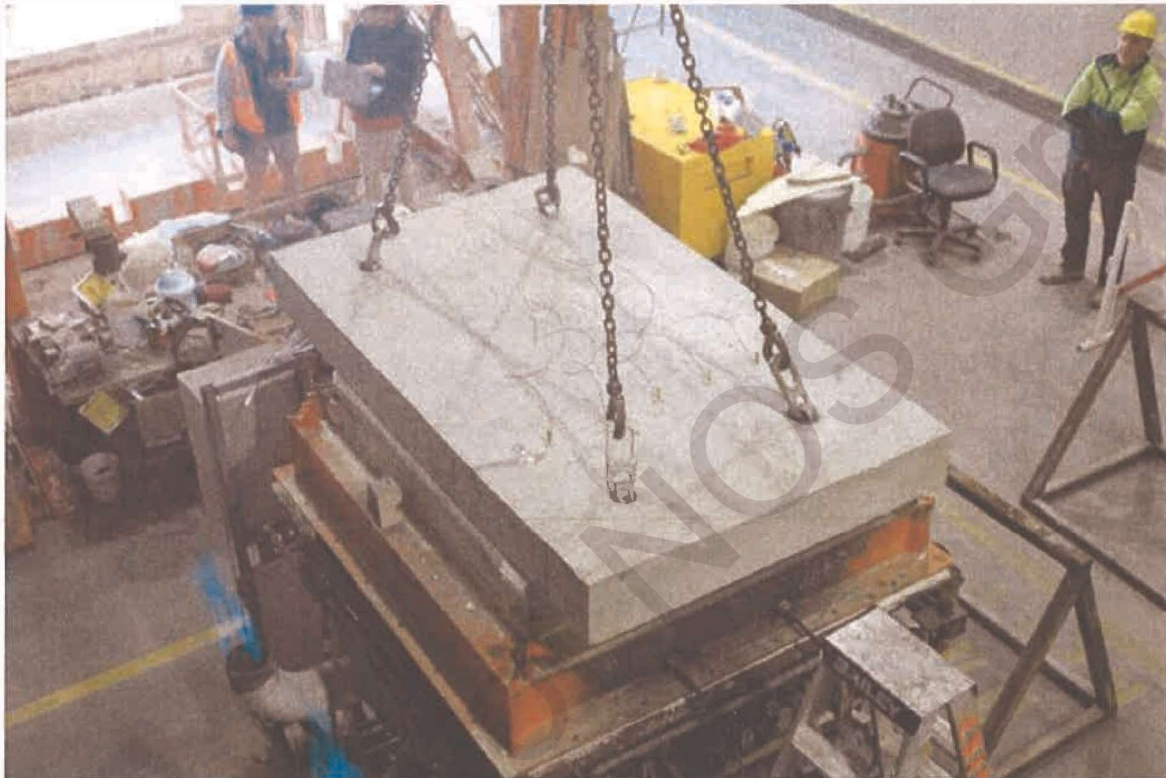
PHOTOGRAPH 9—SPECIMEN SET-UP AT THE CONCLUSION OF TESTING

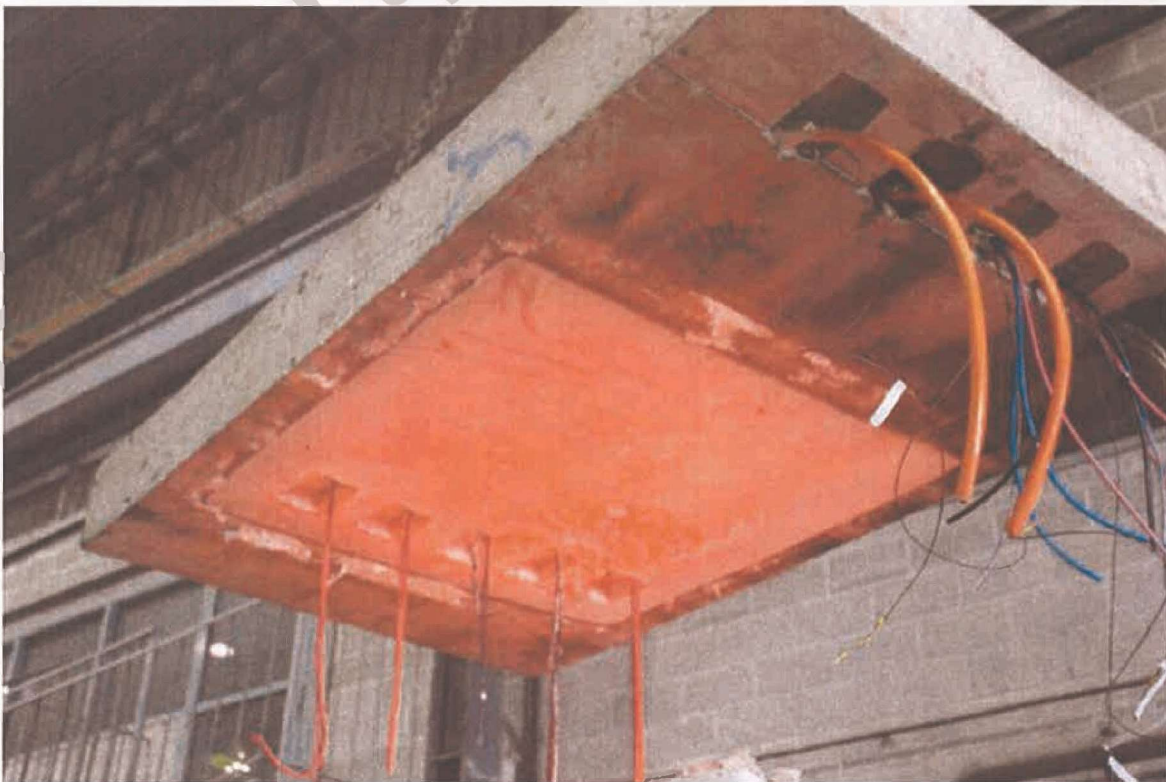
PHOTOGRAPH 10 – EXPOSED FACE OF THE CONCRETE FLOOR AFTER THE CONCLUSION OF TESTING

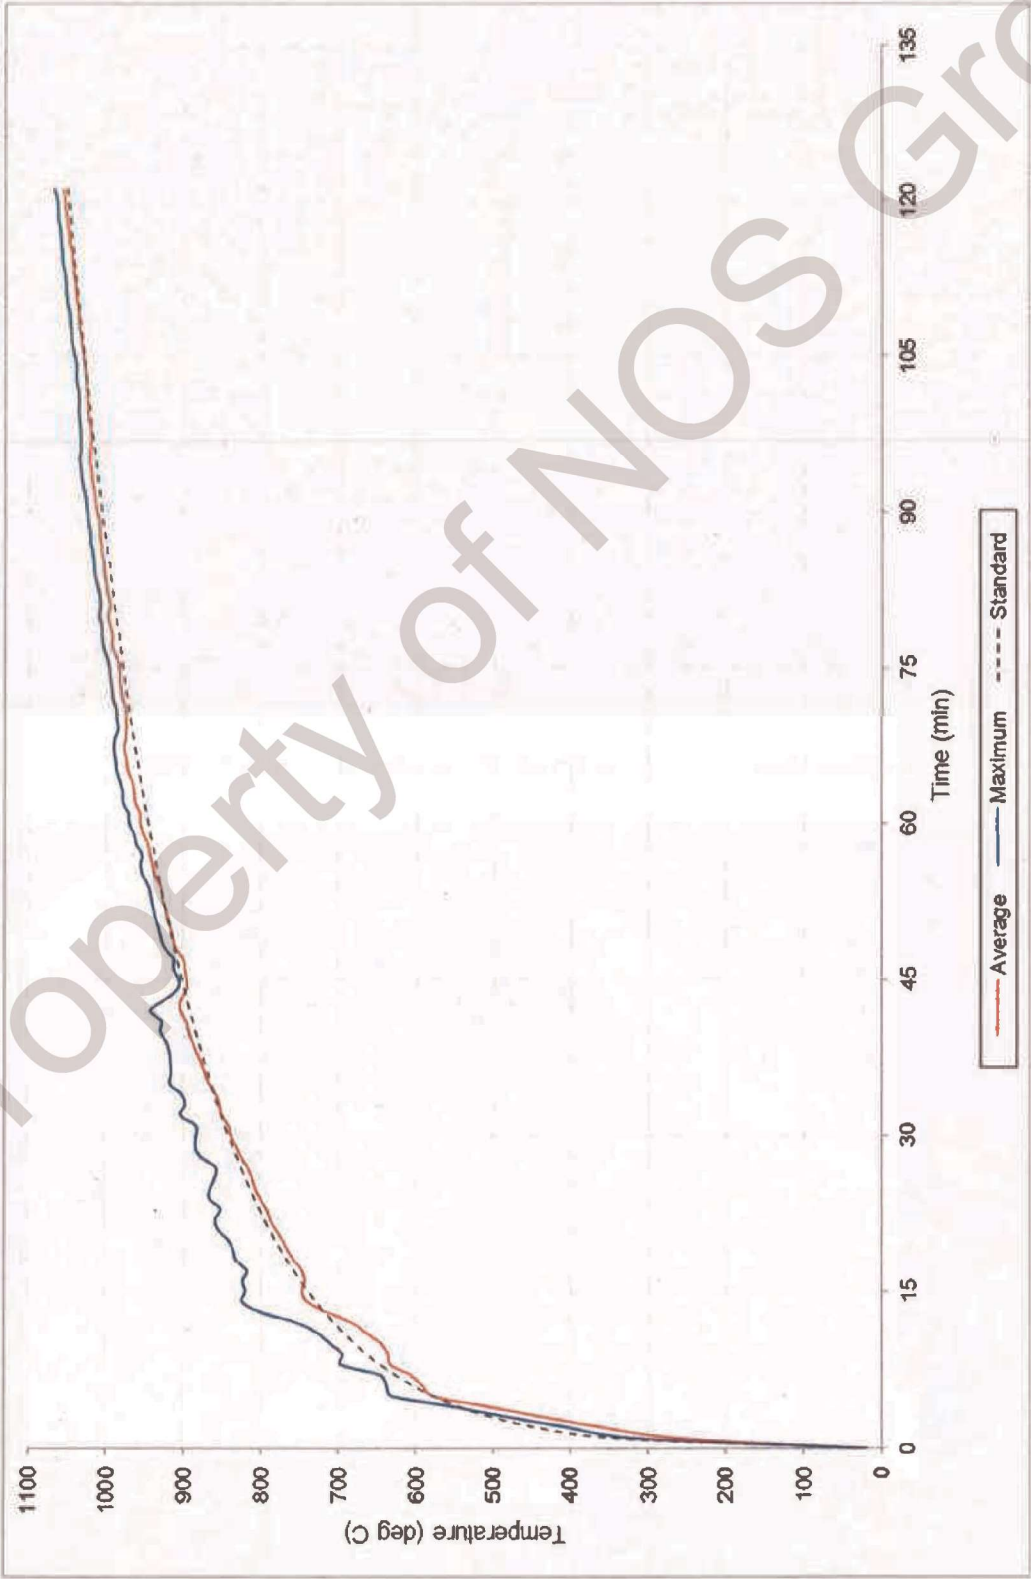
FIGURE 1 – FURNACE TEMPERATURE

Figure 1 shows the standard curves of temperature versus time for heating the furnace chamber and the actual curves of average and maximum temperature versus time recorded during the heating period.

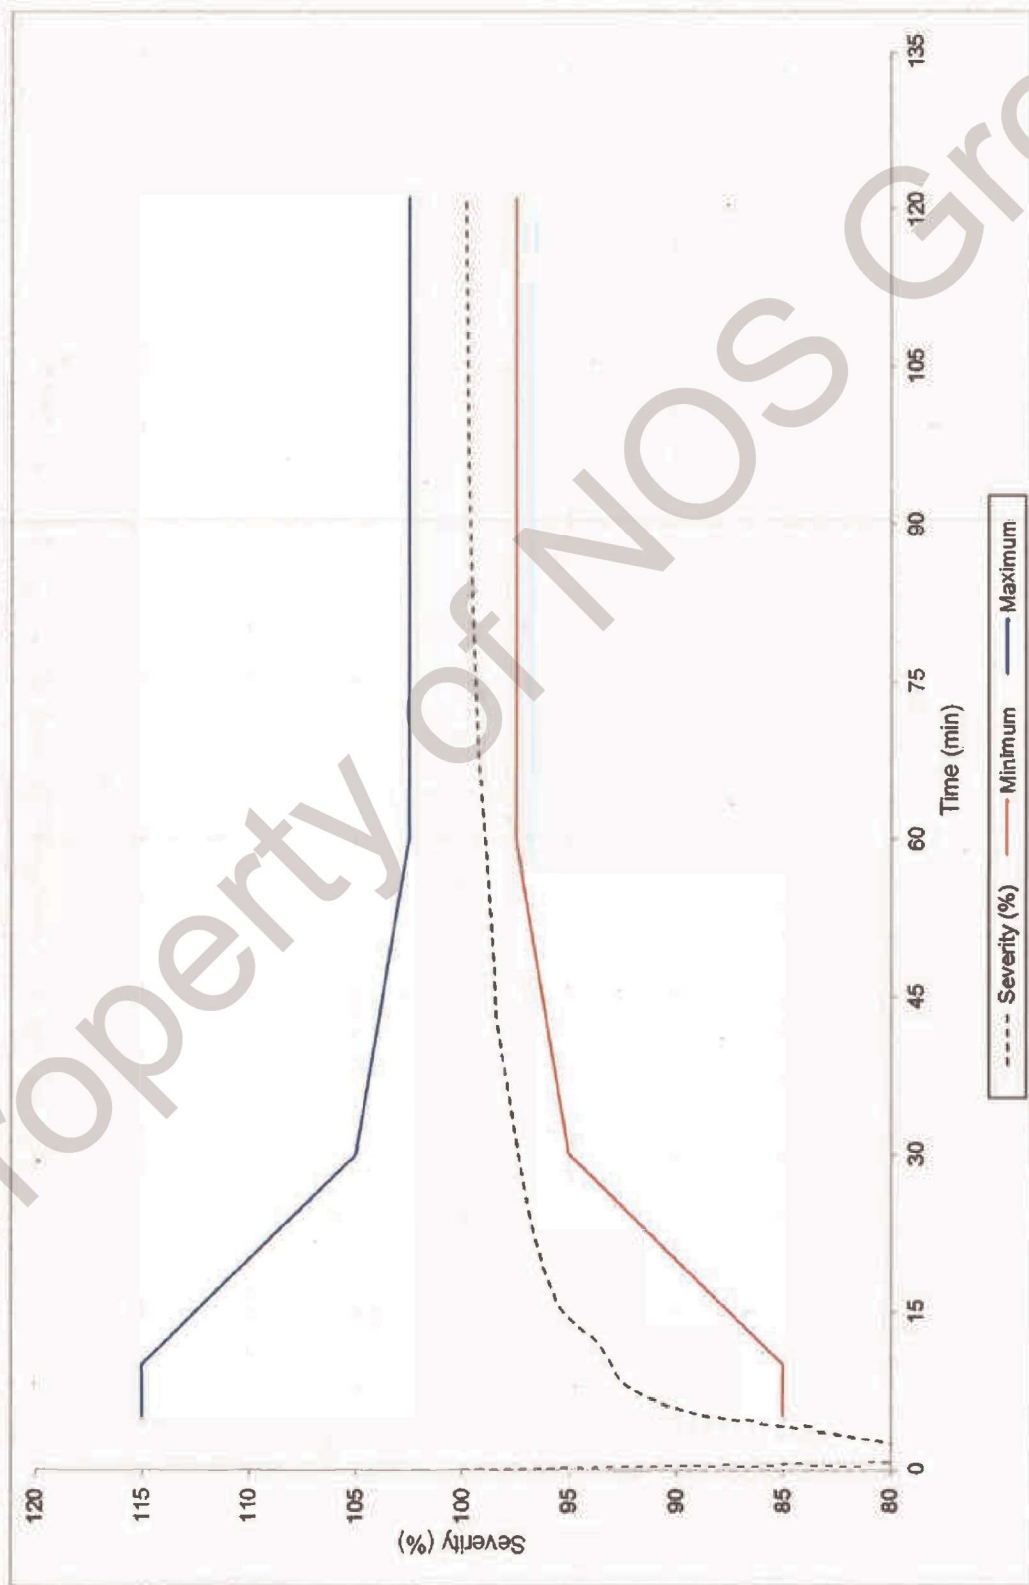
FIGURE 2 – FURNACE SEVERITY

Figure 2 shows the curve of furnace severity versus time during the heating period.

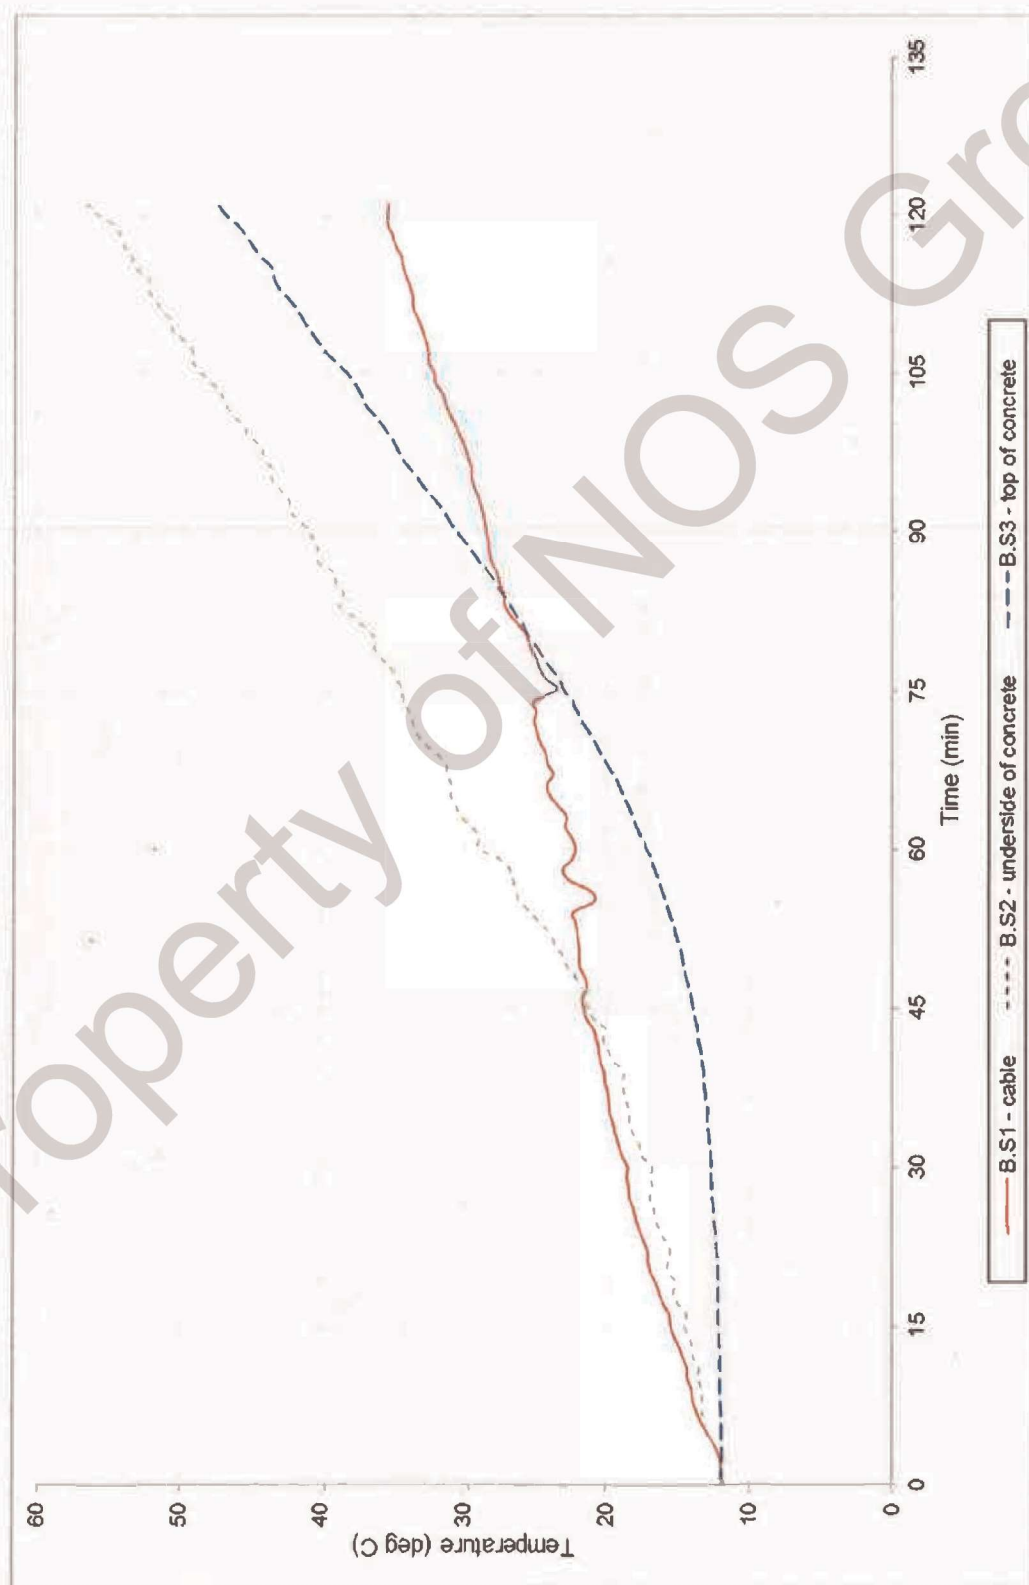
FIGURE 3 – SPECIMEN TEMPERATURE – UNEXPOSED FACE OF SPECIMEN 1

Figures 3 to 7 show curves of temperature versus time recorded on the unexposed face of specimens 1 to 5.

SPECIMEN 1		
Structural adequacy	-	not applicable
Integrity	-	no failure at 121 minutes
Insulation	-	no failure at 121 minutes
SPECIMEN 2		
Structural adequacy	-	not applicable
Integrity	-	no failure at 121 minutes
Insulation	-	no failure at 121 minutes
SPECIMEN 3		
Structural adequacy	-	not applicable
Integrity	-	no failure at 121 minutes
Insulation	-	no failure at 121 minutes

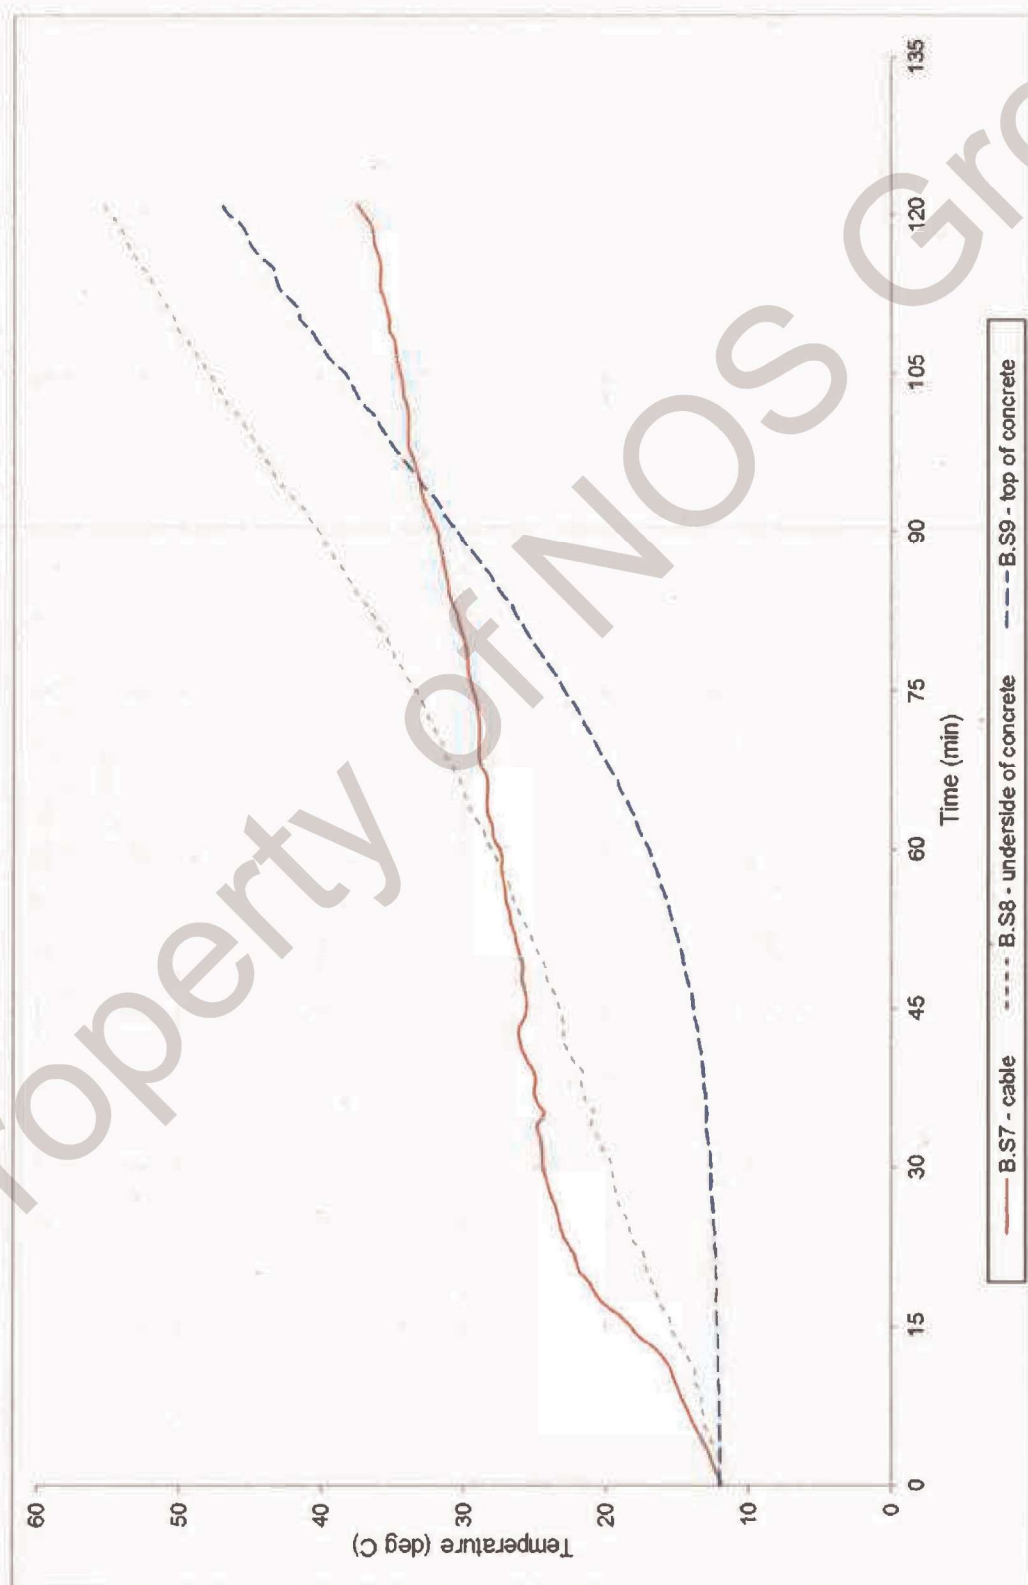
FIGURE 5 – SPECIMEN TEMPERATURE – UNEXPOSED FACE OF SPECIMEN 3

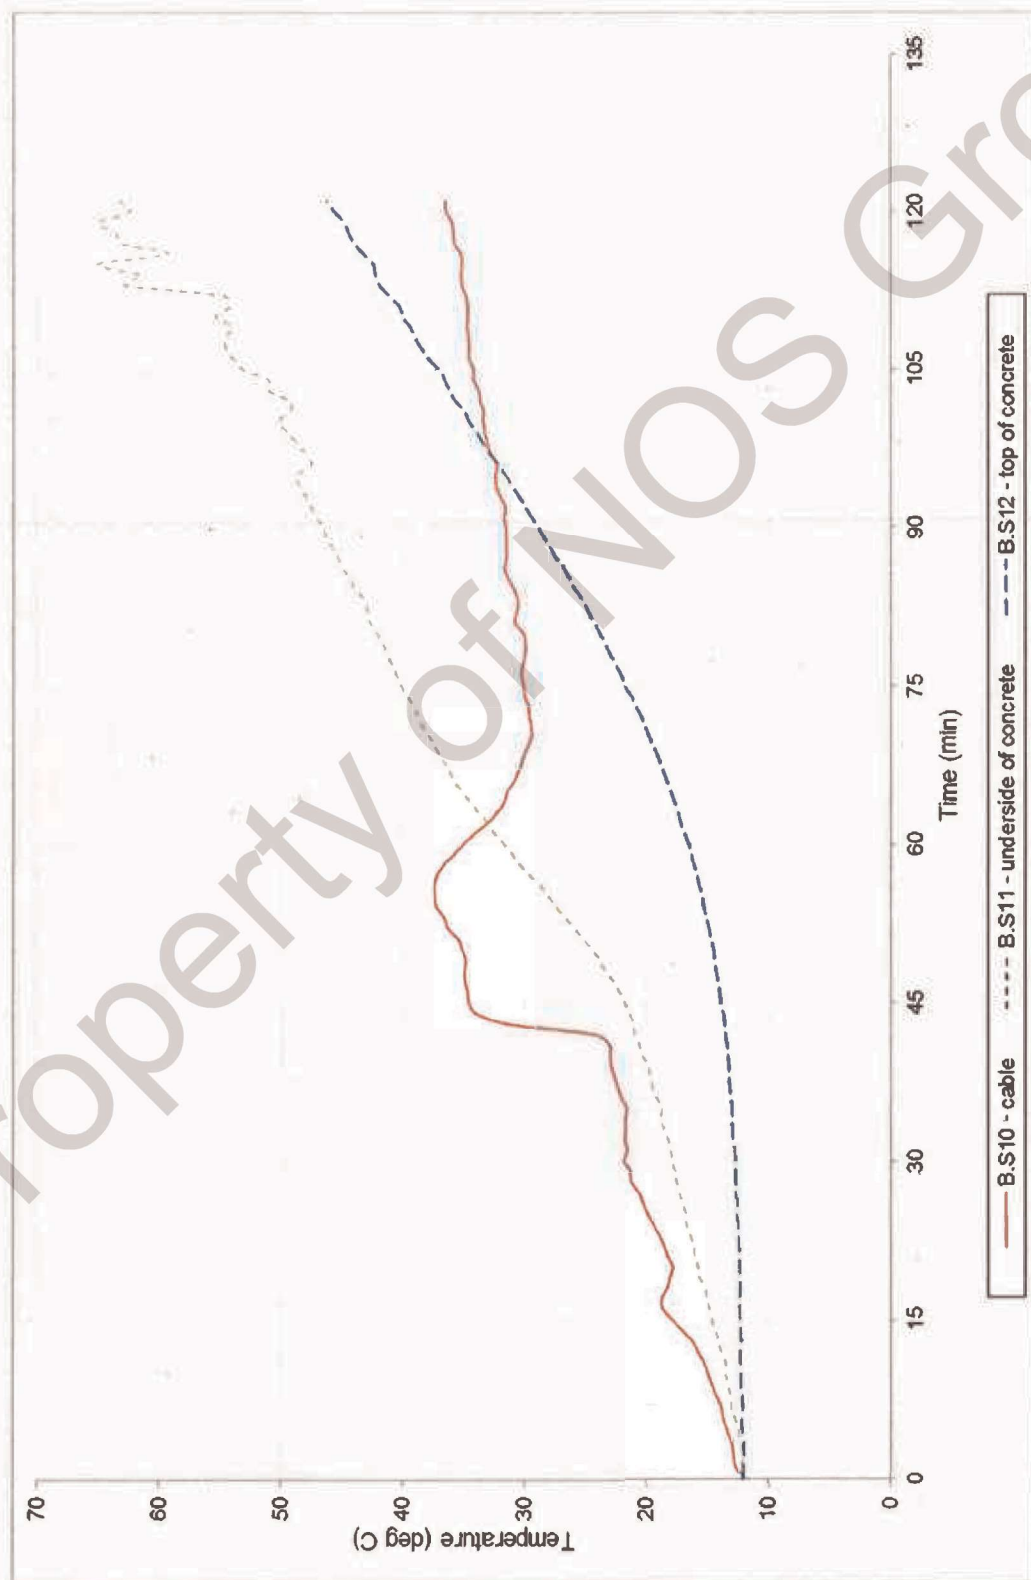
FIGURE 6 – SPECIMEN TEMPERATURE – UNEXPOSED FACE OF SPECIMEN 4

<b>SPECIMEN 4</b>		
Structural adequacy		not applicable
Integrity		no failure at 121 minutes
Insulation		no failure at 121 minutes

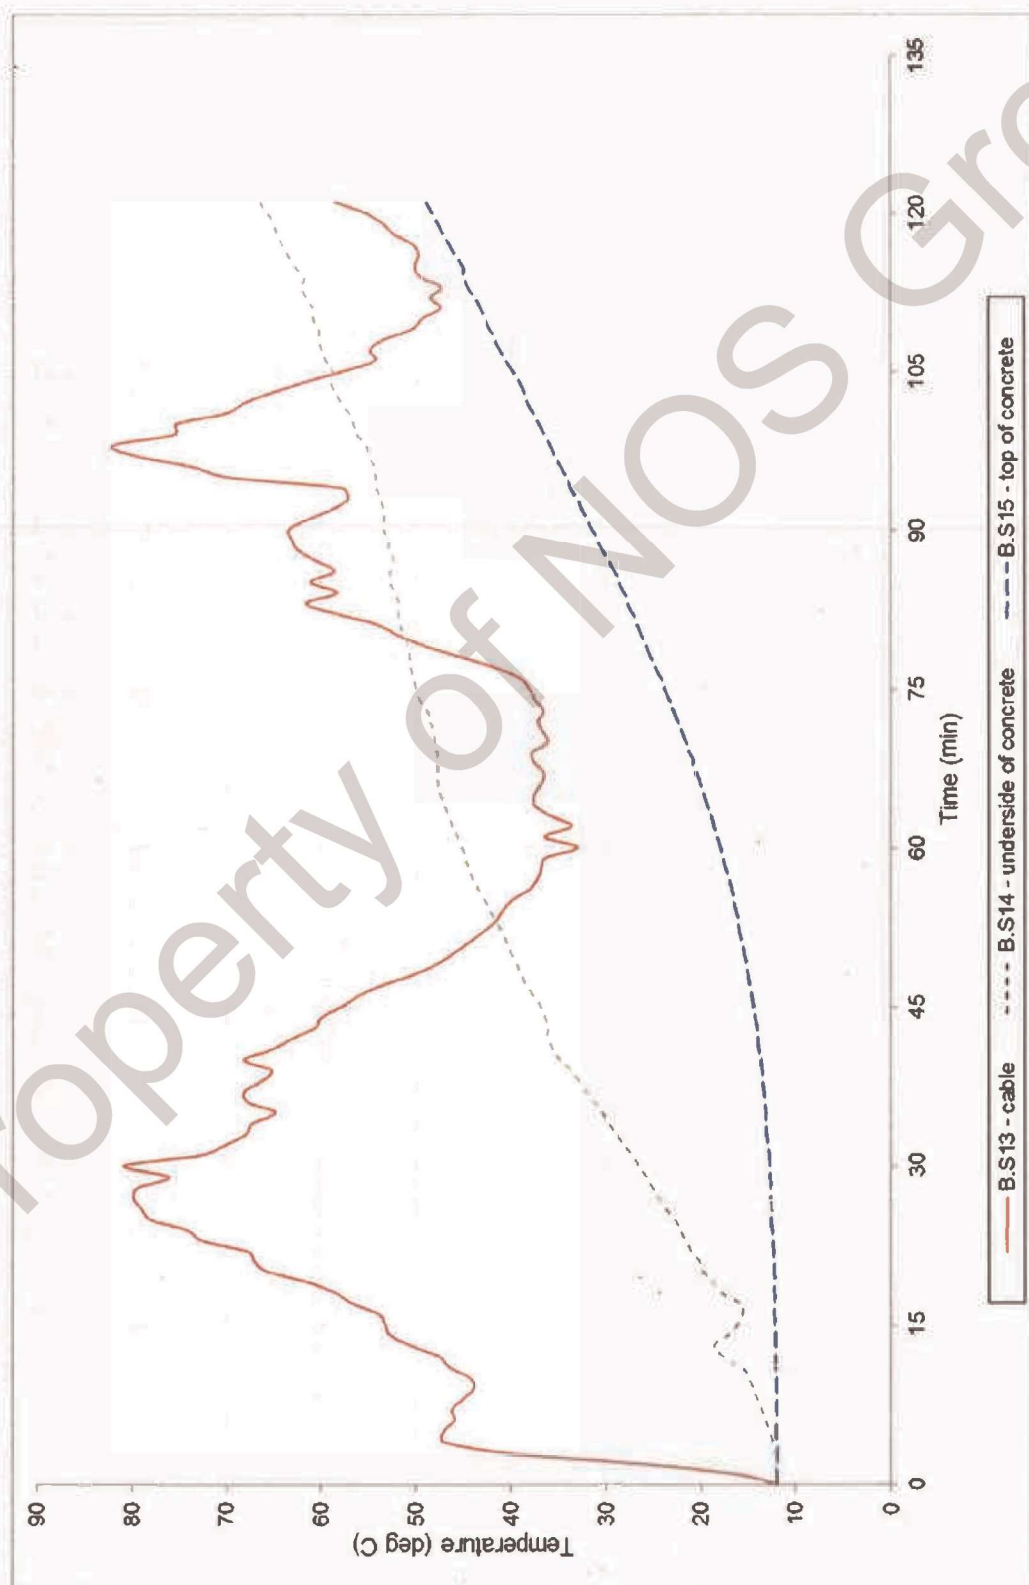
FIGURE 7 – SPECIMEN TEMPERATURE – UNEXPOSED FACE OF SPECIMEN 5

<b>SPECIMEN 5</b>		
Structural adequacy		not applicable
Integrity		no failure at 121 minutes
Insulation		no failure at 121 minutes

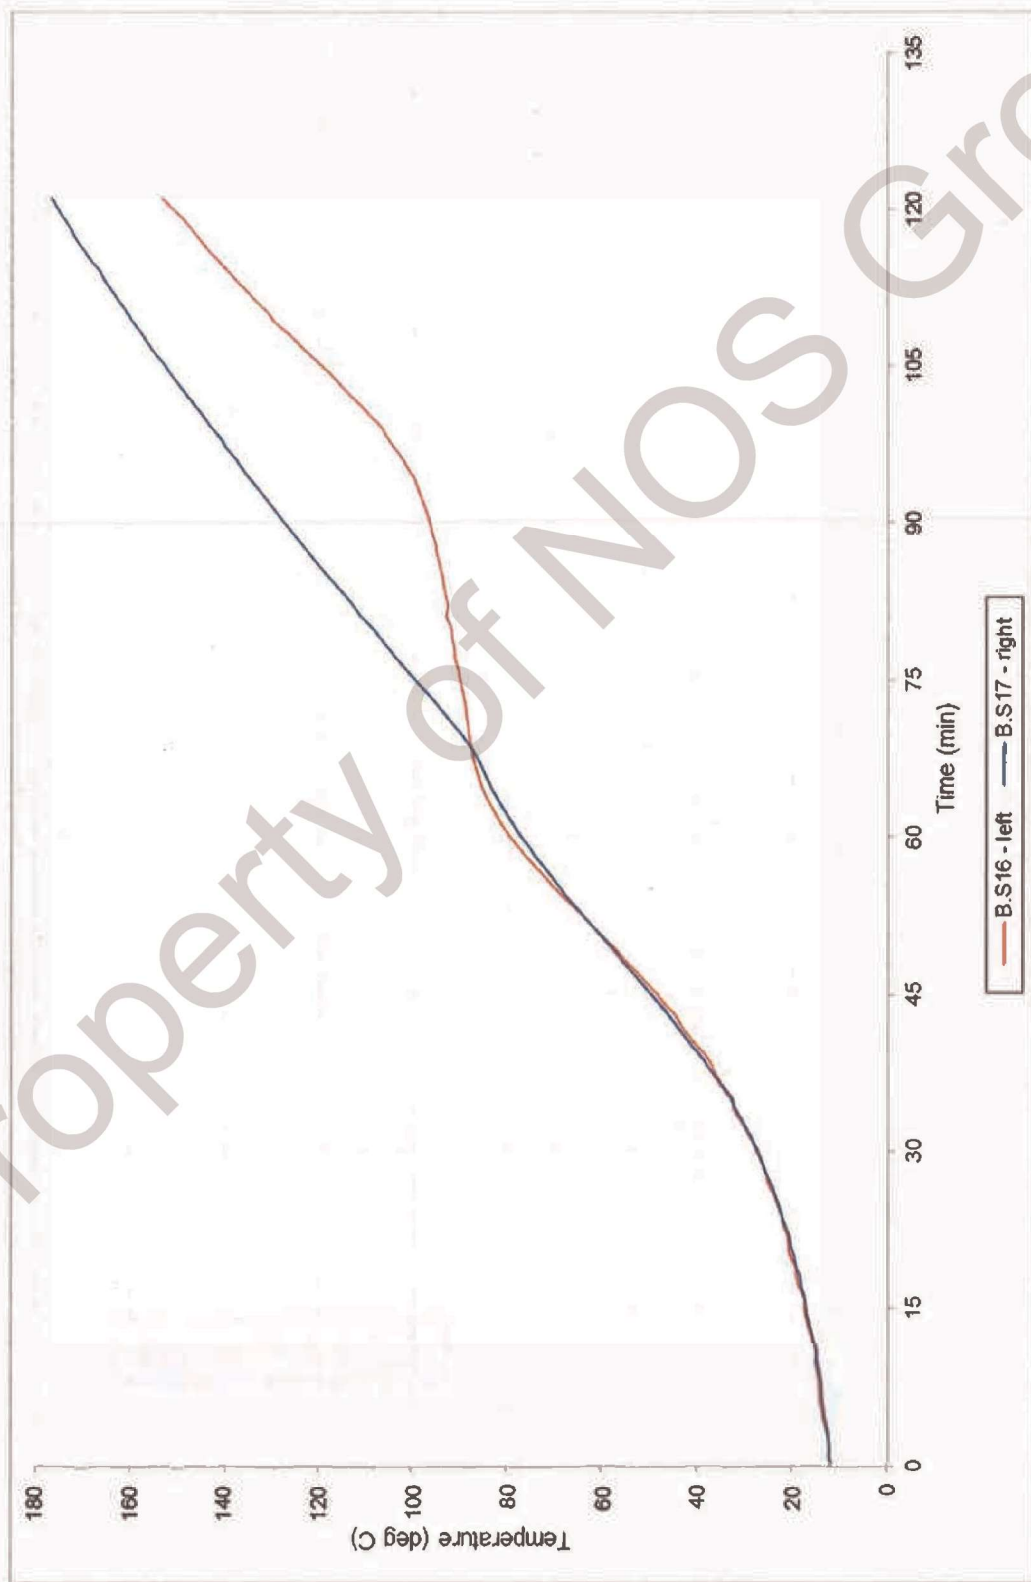
FIGURE 8 – SPECIMEN TEMPERATURE – UNEXPOSED FACE OF FIRE SEPARATING WALL

Figure 8 shows curves of temperature versus time recorded on the unexposed face of the fire separating wall.
